# **More than 50 injured in train crash at Barcelona's Estacio de Franca**

**Many passengers were standing ready to get off at the time of the collision that crumpled the front of the carriage.**

Friday 28 July 2017 14:01, UK

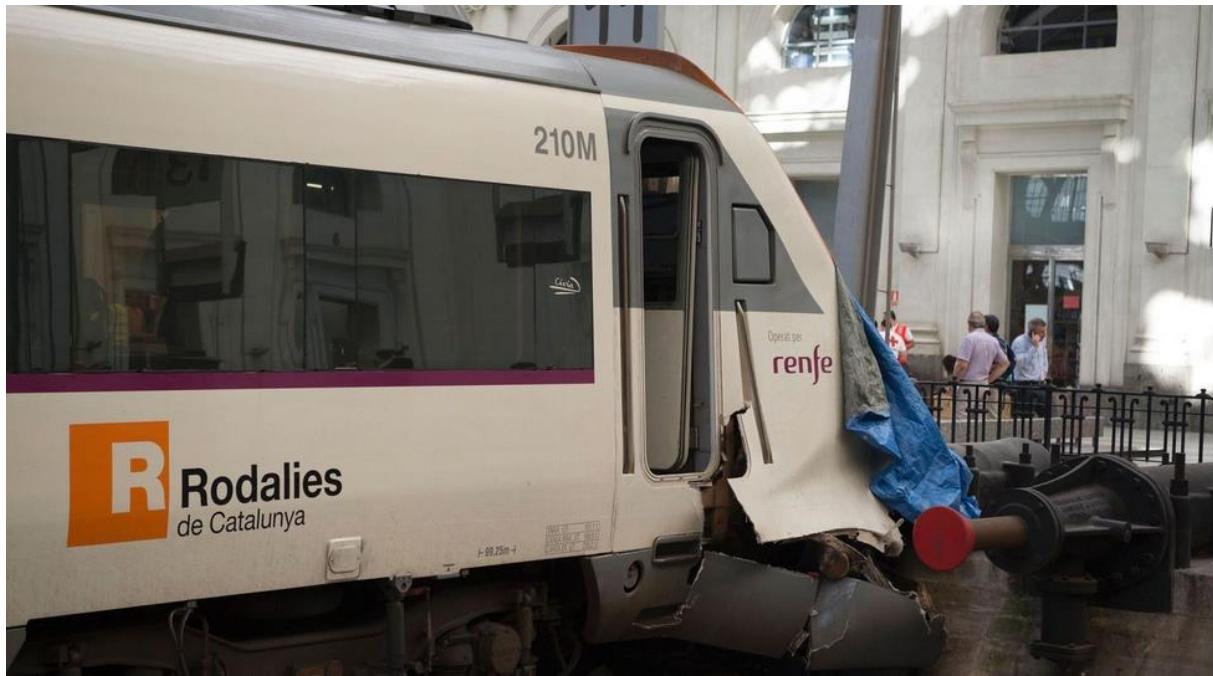
Als erstes wurden die Effekte der Kollision abgedeckt.

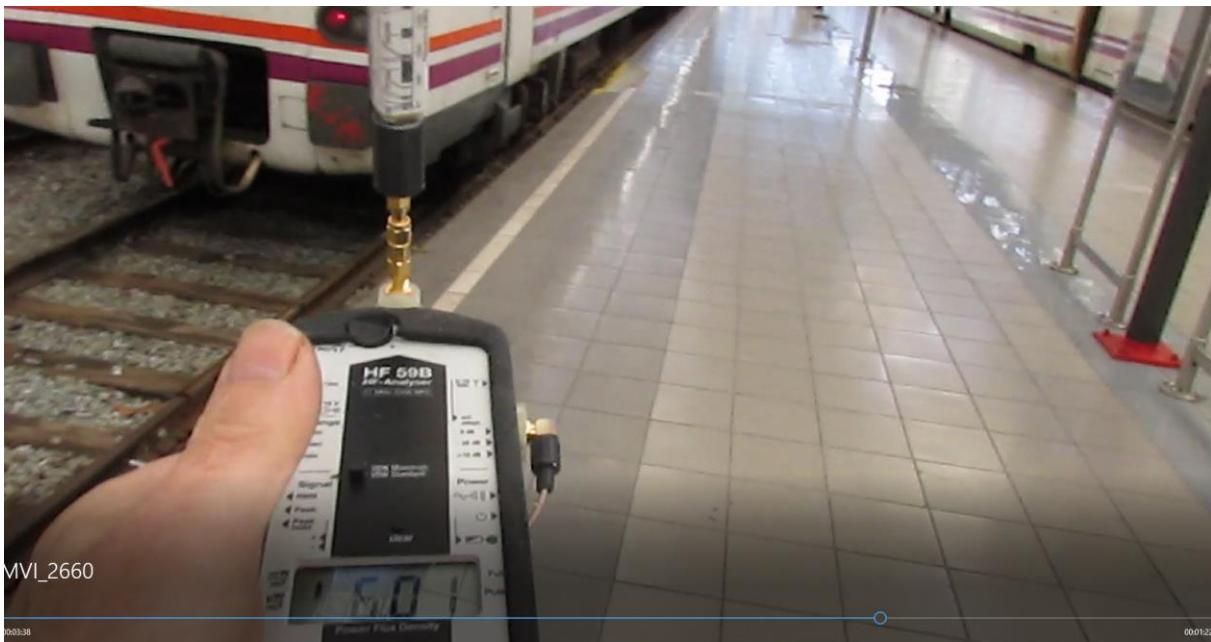
Eigene Messung am 29.12.2017: nun auf Höhe der Bahnangestellten auf obigem Foto:

Die (hohe) Belastung durch Funksignale aus der Halle an dieser Stelle ist bestätigt.

Am Perronkopf, beim Einfahren, beträgt die Belastung 0.1- 0.3mW/peak.

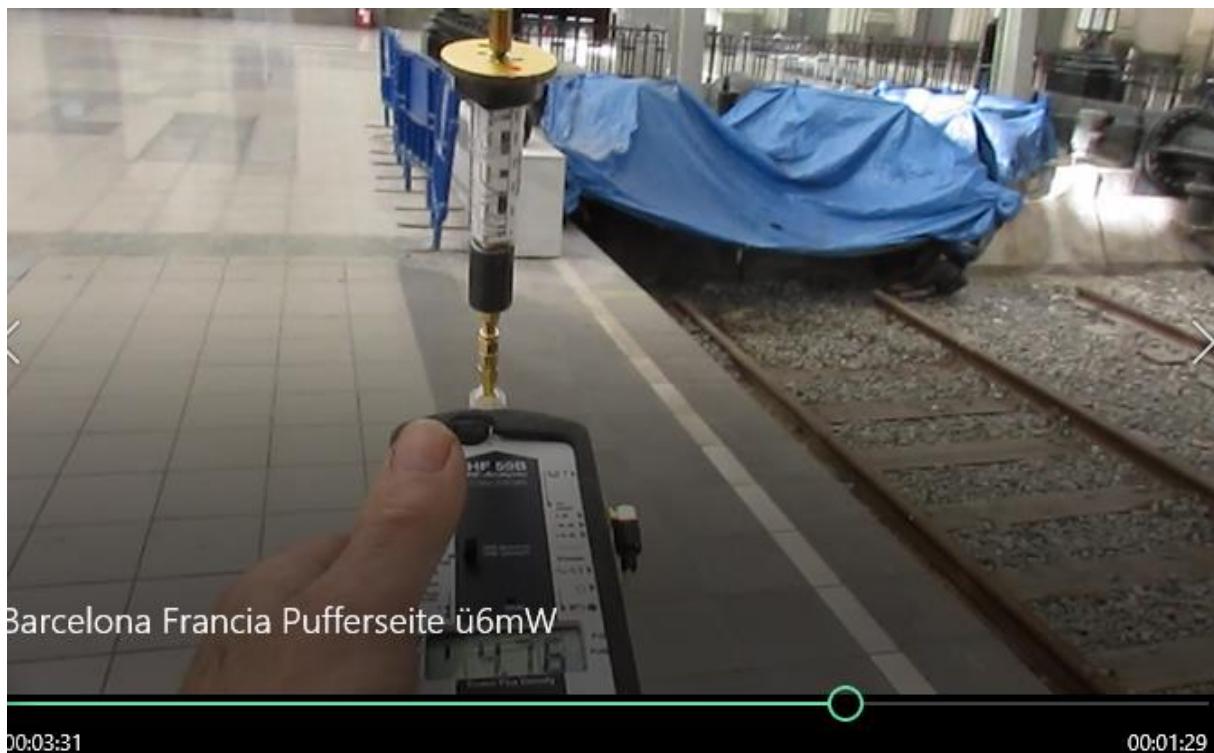
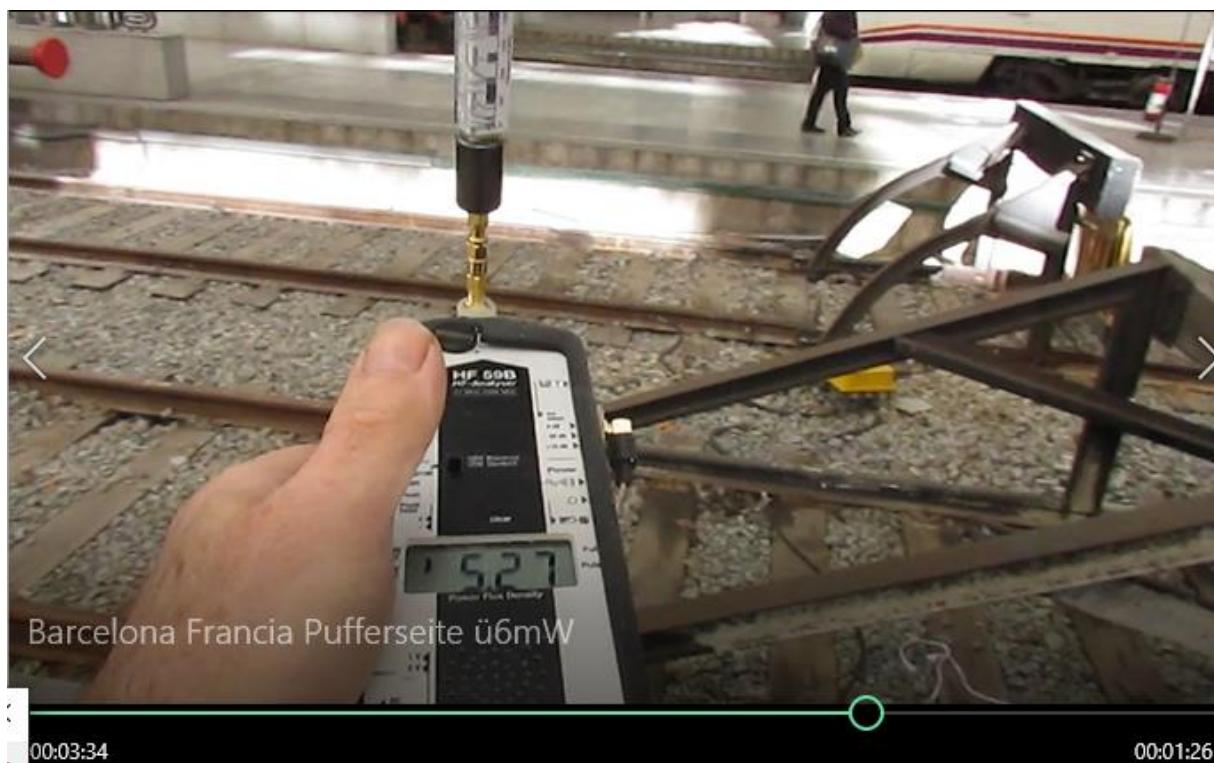
Die defekten Puffer stehen noch wie beim Unfall, sind mit den gleichen Planen abgedeckt...

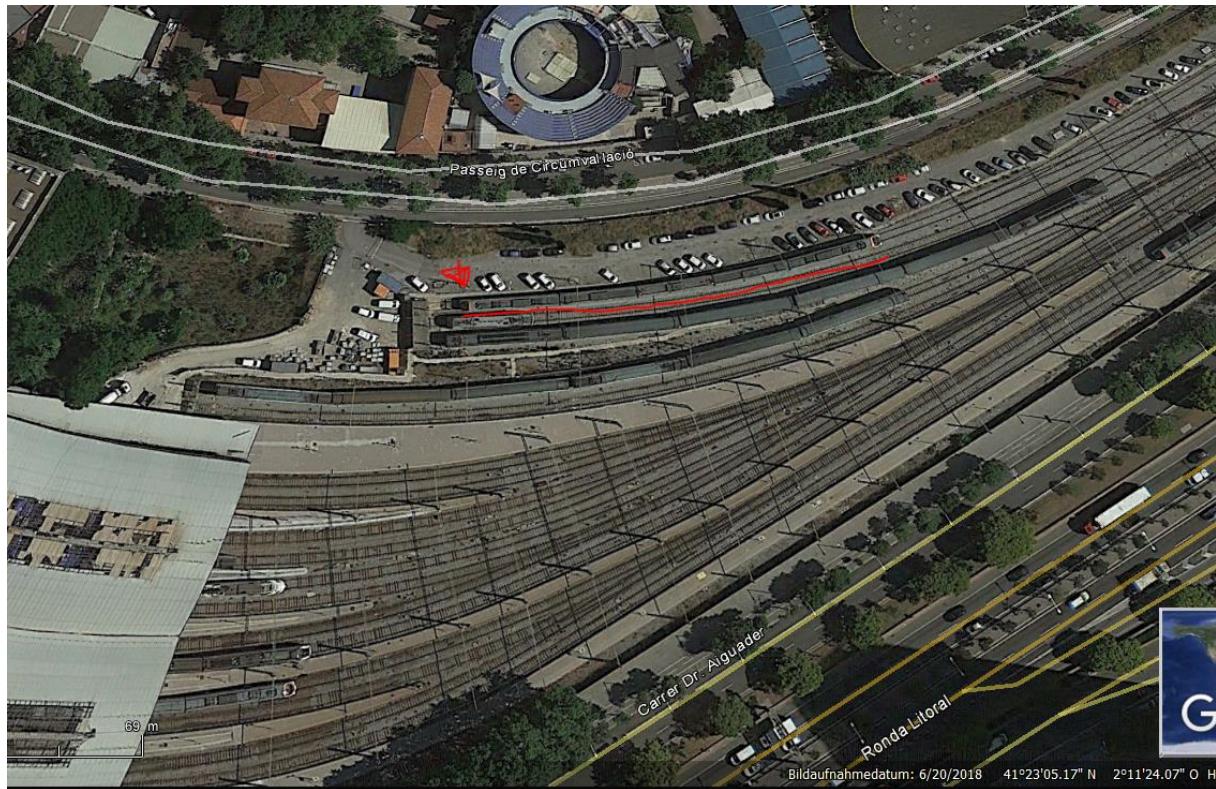
Der Zug steht auch im Winter 2018/19 noch ausserhalb auf einem Rangiergleis, so, wie er auf den Bildern aussieht.
