# **More than 50 injured in train crash at Barcelona's Estacio de Franca**

**Many passengers were standing ready to get off at the time of the collision that crumpled the front of the carriage.**

Friday 28 July 2017 14:01, UK

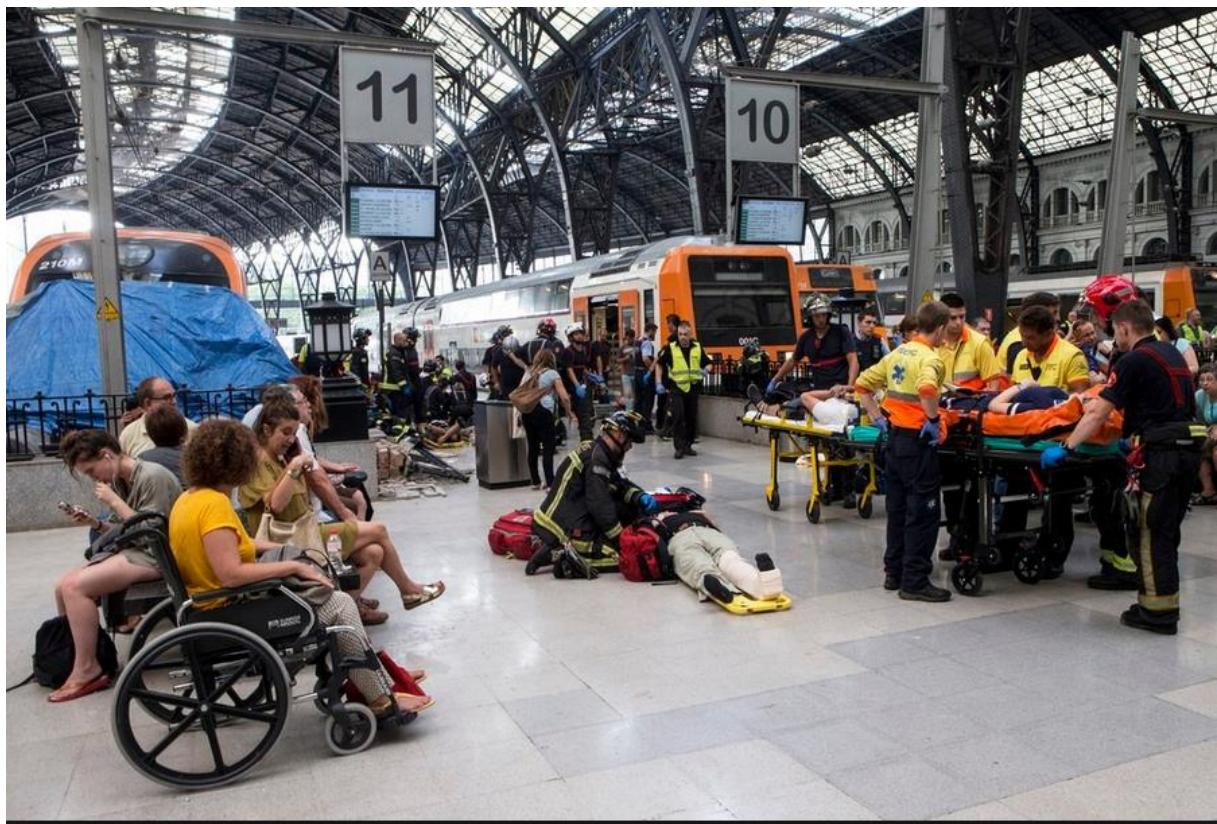
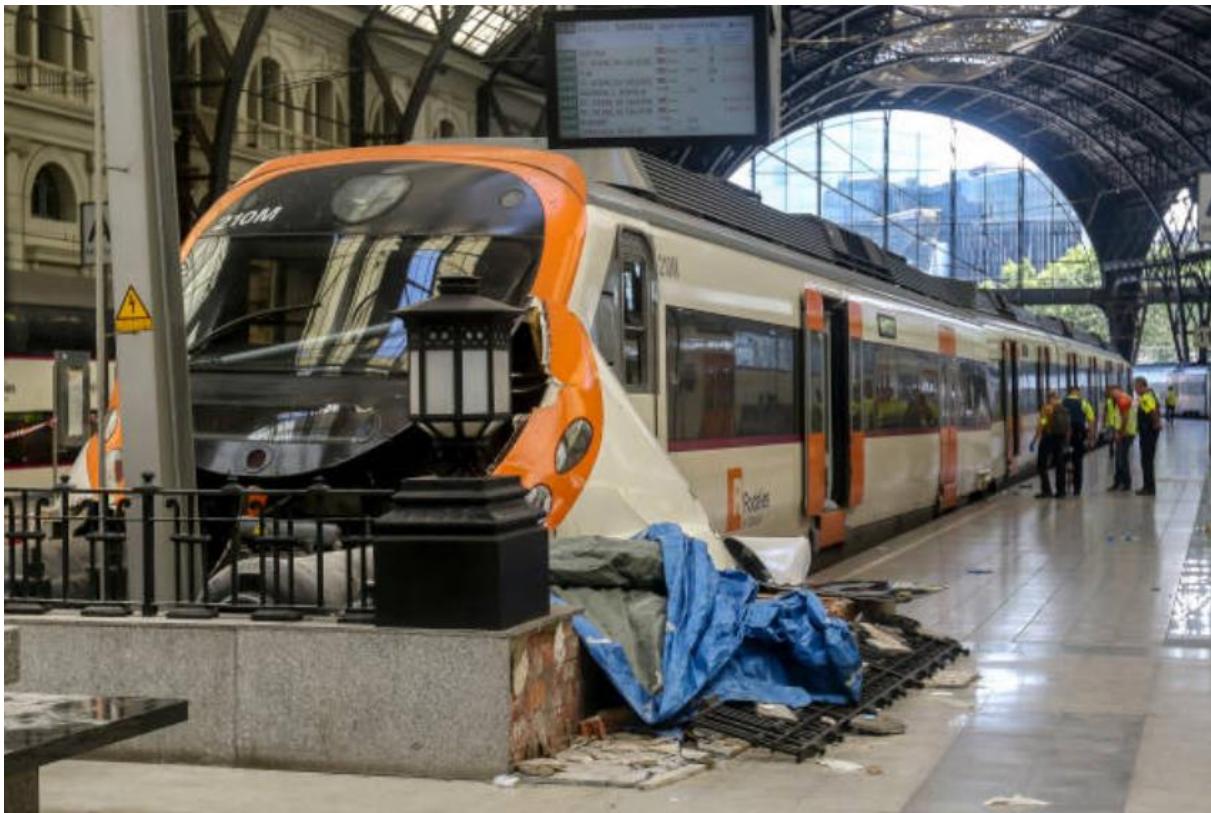
Als erstes wurden die Effekte der Kollision abgedeckt.

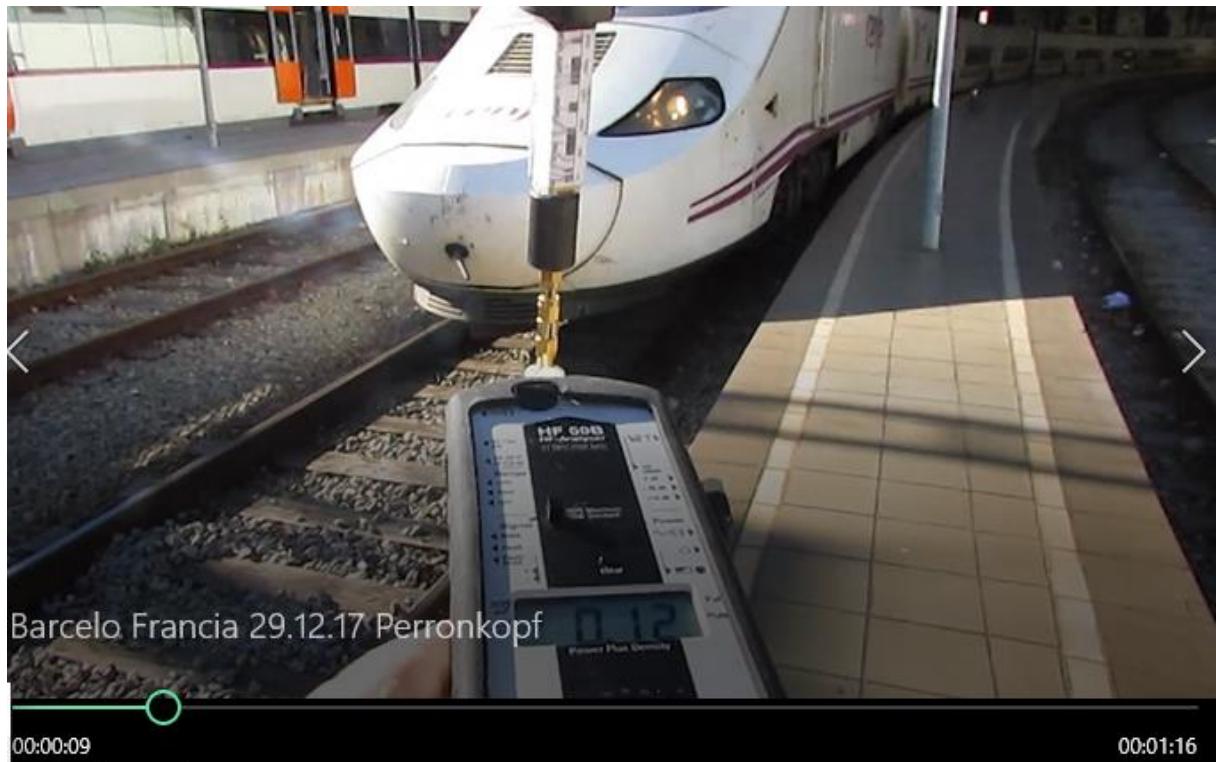
Die (hohe) Belastung durch Funksignale aus der Halle an dieser Stelle ist bestätigt.

Am Perronkopf, beim Einfahren, beträgt die Belastung 0.1- 0.3mW/peak.

Hier hat der Zug wie üblich verzögert.
